**INVESTIGATION OF SOLVENT RESISTANT TREATMENTS  
FOR BITUMINOUS PAVEMENTS**

**TECHNICAL MEMORANDUM NO. 3-246**

**WATERWAYS EXPERIMENT STATION  
VICKSBURG, MISSISSIPPI**

**DECEMBER 1947**

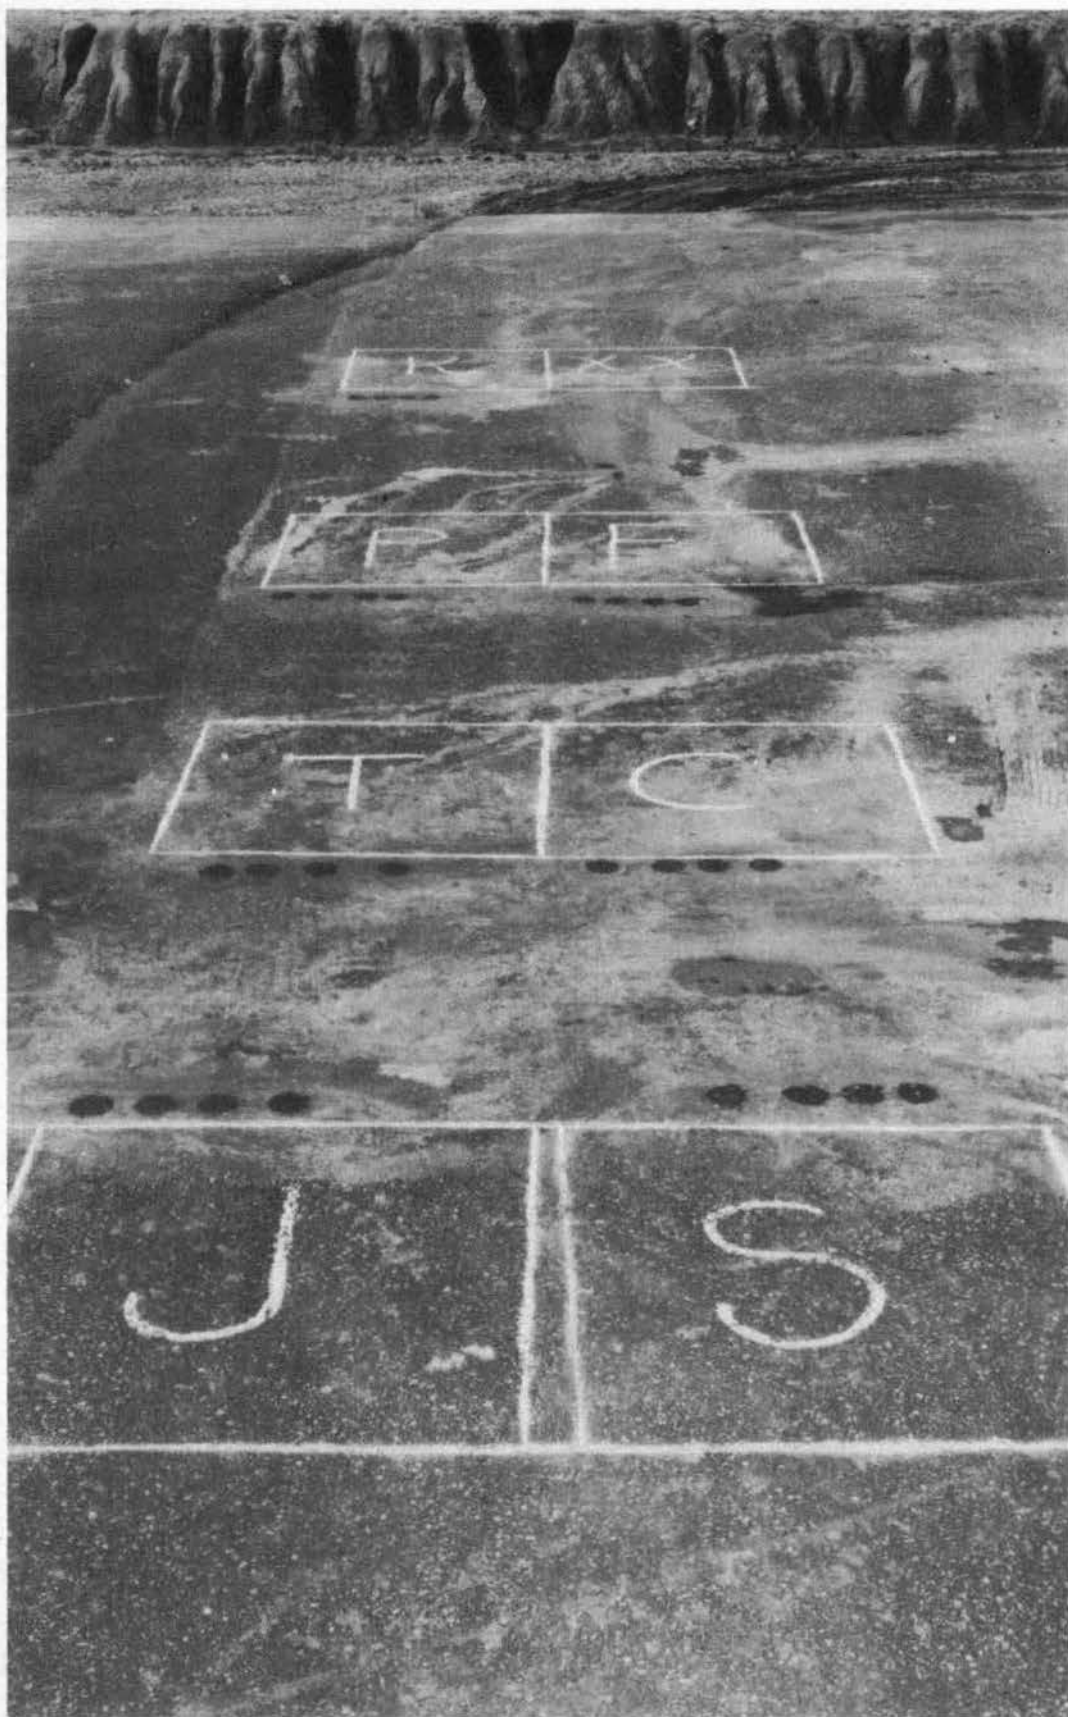
PHOTOGRAPH 8

GENERAL VIEW OF AREA SELECTED FOR TESTING SURFACING MATERIALS

31. An asphaltic concrete of good quality and uniform texture which behaved satisfactorily under traffic was selected in the east turnaround of the asphalt test section as the site for the field tests. Areas of the pavement 4 ft square were removed and replaced by the pavements listed above. Photographs 11 and 12 show the pavements as placed. The pavement mixes were prepared in a pug mill mixer in the laboratory and transported to the field while still hot. The temperature of the tar concrete at the time of placing was 250° F while the other mixes were placed at 300° F. The mixes were placed by hand and rolled with 16 passes of an 8-ton tandem roller. Stability and flow values, unit weights, and per cent voids for cored samples of the in-place pavements are given in table 5.

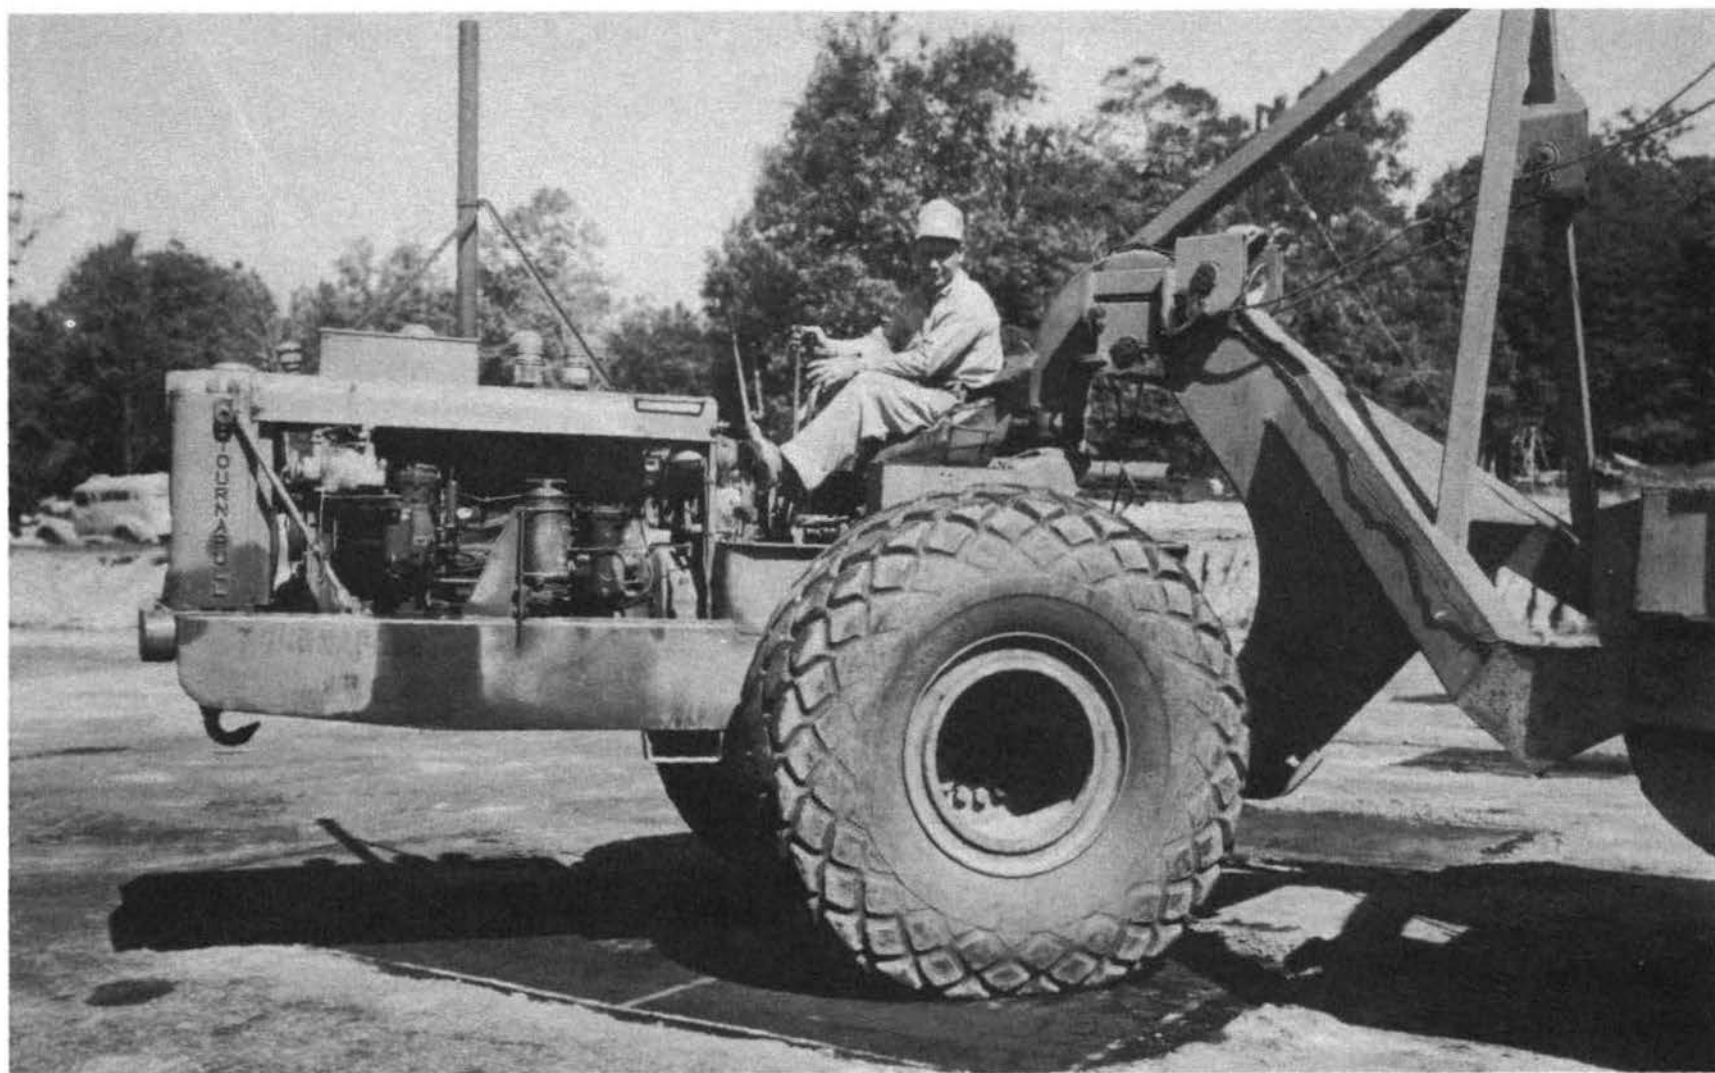
PHOTOGRAPH 14

TOURNAPULL IN TESTING POSITION

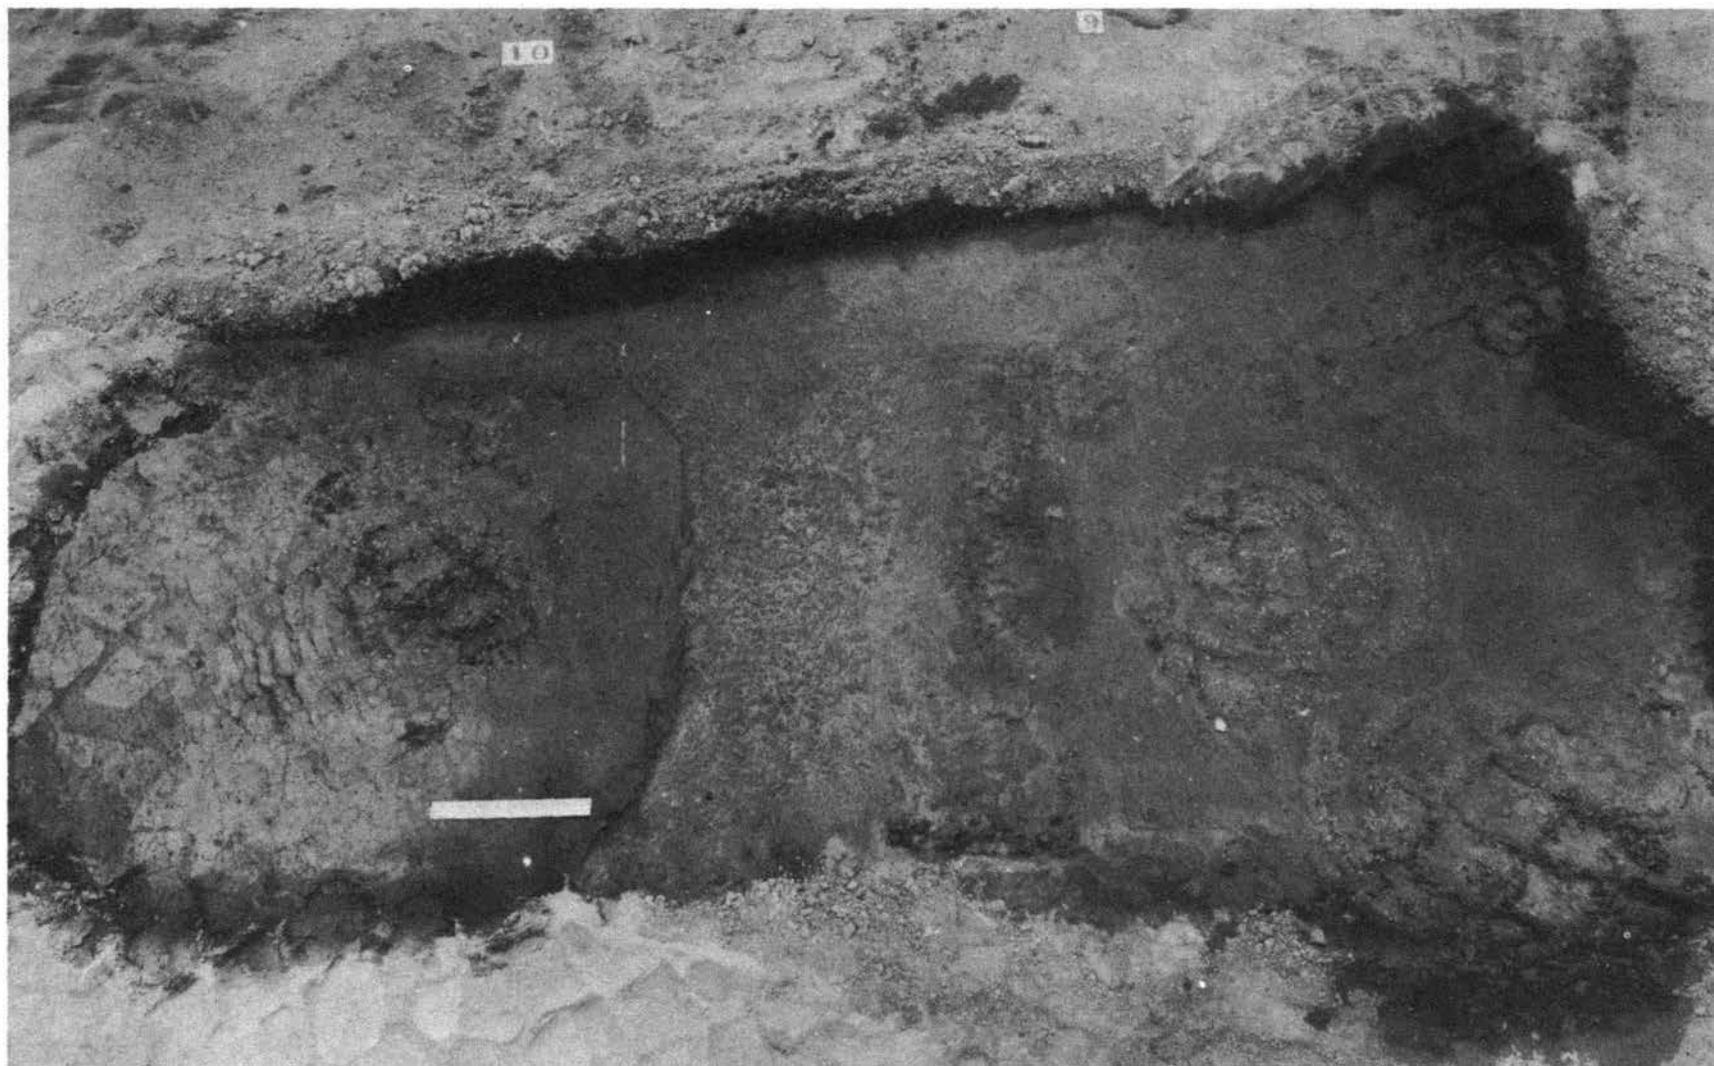
PHOTOGRAPH 18

KEROSENE SATURATED TEST AREAS AFTER 10 CYCLES

The pavement was rigid enough after 10 cycles that the roller cracks could still be seen plainly (photograph 17) although a slight amount of shearing and tearing out of aggregate had started. The aggregate gradation for this mix was the same as shown on plate 2 and made a very low stability mix when tar was used as a binder. Reference to table 5 shows that the original in-place stability was only 102 lb and that no value could be obtained for pavement after testing. The pavement was too granular to be cored, yet it was the most satisfactory of any tested under these testing conditions. Results of laboratory tests on cores from bituminous test areas at MacDill Field, Florida, indicate that a high-stability tar concrete can be constructed. In view of this, the lack of stability in the tar concrete tested assumes minor importance since this may be compensated for by proper design.

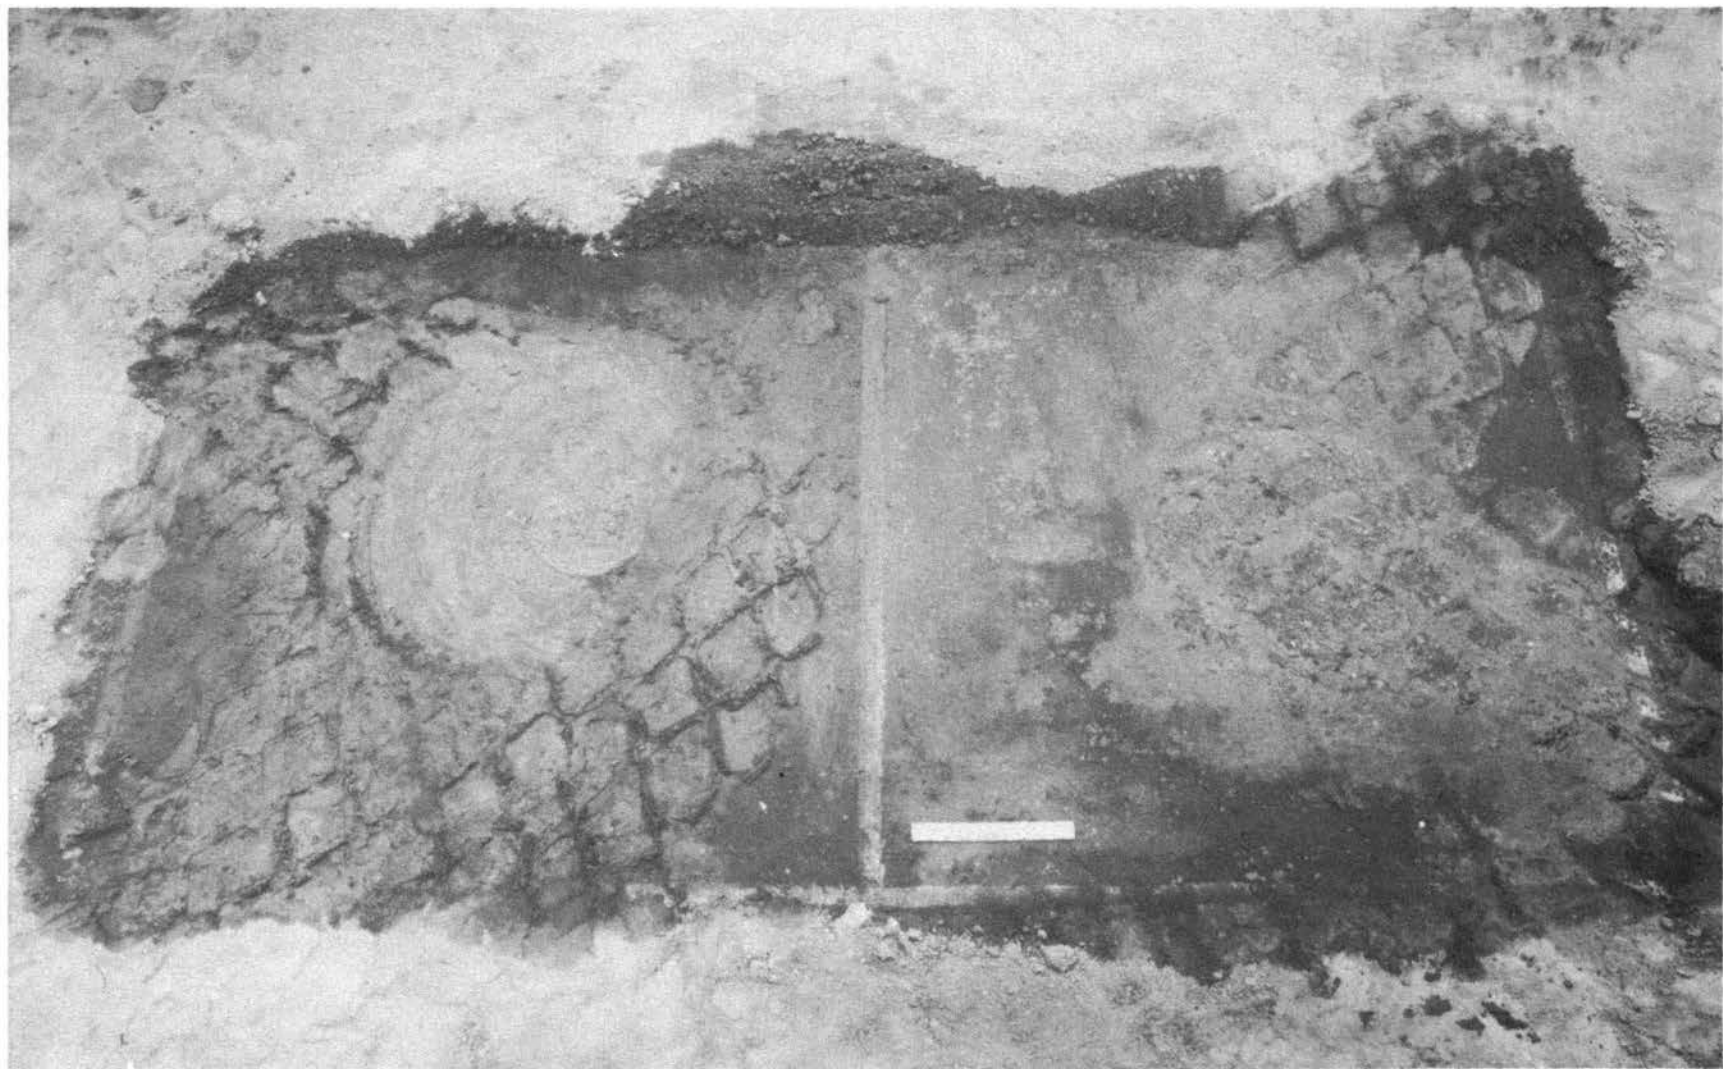
KEROSENE SATURATED TEST AREAS AFTER 5 CYCLES

KEROSENE SATURATED TEST AREAS AFTER 10 CYCLES

46. Tar seal. The tar seal was prepared with 0.25 gal of RT-10 tar per sq yd with enough sand to blot up all free tar. Though the surface was six days old when the testing began, it was not cured. The tire tracked in the first cycle. The sand-tar mix formed a lubricant in which the tire slid without damage to the pavement below. The pavement aggregate was beginning to strip in the eighth cycle and continued to strip slightly until the end of the test. Photographs 22 and 23 show

the test area after 5 and 10 cycles. The tar seal protected the pavement until it was displaced, and only slight stripping of the pavement was noted at the end of the field test.

47. Cordo 3M-219#1. This vinylite solution was painted on the surface. A slight scum was formed during the third cycle. The solution was clear so that it was very difficult to determine when the aggregate was scrubbed clean. Scouring of the treatment and slight stripping of pavement aggregate was noted in the third cycle. Photograph 22 shows the test area at the end of the fifth cycle with very little scum and no loose aggregate. The solvent attacked the unprotected pavement where the Cordo was scrubbed away, but the attack seemed slow. No scour of the pavement took place. Photograph 23 shows the test area after 10 cycles.
